APPLICATION PACKAGE
NYSDEC WATER WITHDRAWAL PERMIT

CLOVEWOOD WATER SYSTEM
BLAGGS CLOVE
VILLAGE OF SOUTH BLOOMING GROVE
ORANGE COUNTY, NEW YORK

PROJECT NO.: 31404120.000
DATE: APRIL 2018
(REVISED: JULY 2023)
(REVISED: SEPTEMBER 2023)
(REVISED: OCTOBER 2023)

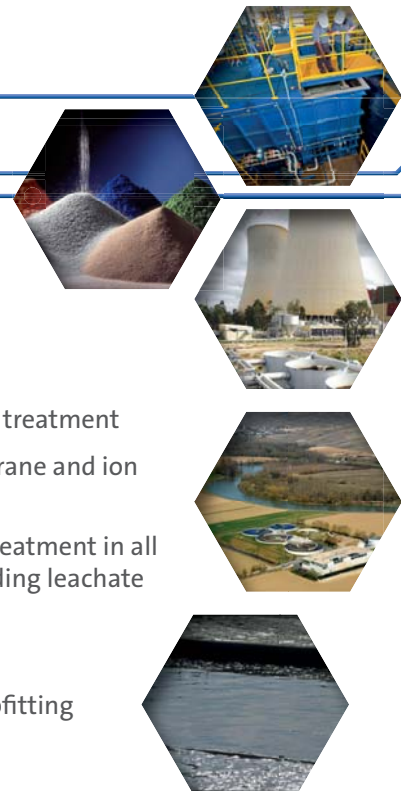
The best package range of microsand enhanced clarifiers

The Actiflo Pack ACP2 units have the same operating characteristics and advantages: fast, high performance treatment and great operational flexibility. Standardized and pre-assembled, Actiflo Pack ACP2 units provide the clients with the most competitive and advanced technologies with minimal engineering costs and **extremely short delivery and commissioning times**. Numerous standard options and alternatives are proposed to enhance performances and monitoring.

Integrating the continuous innovation carried out by Veolia Water Technologies, the Actiflo Pack ACP2 range now includes eight models suitable for flow rates from 300 m³/d to 43 000 m³/d.

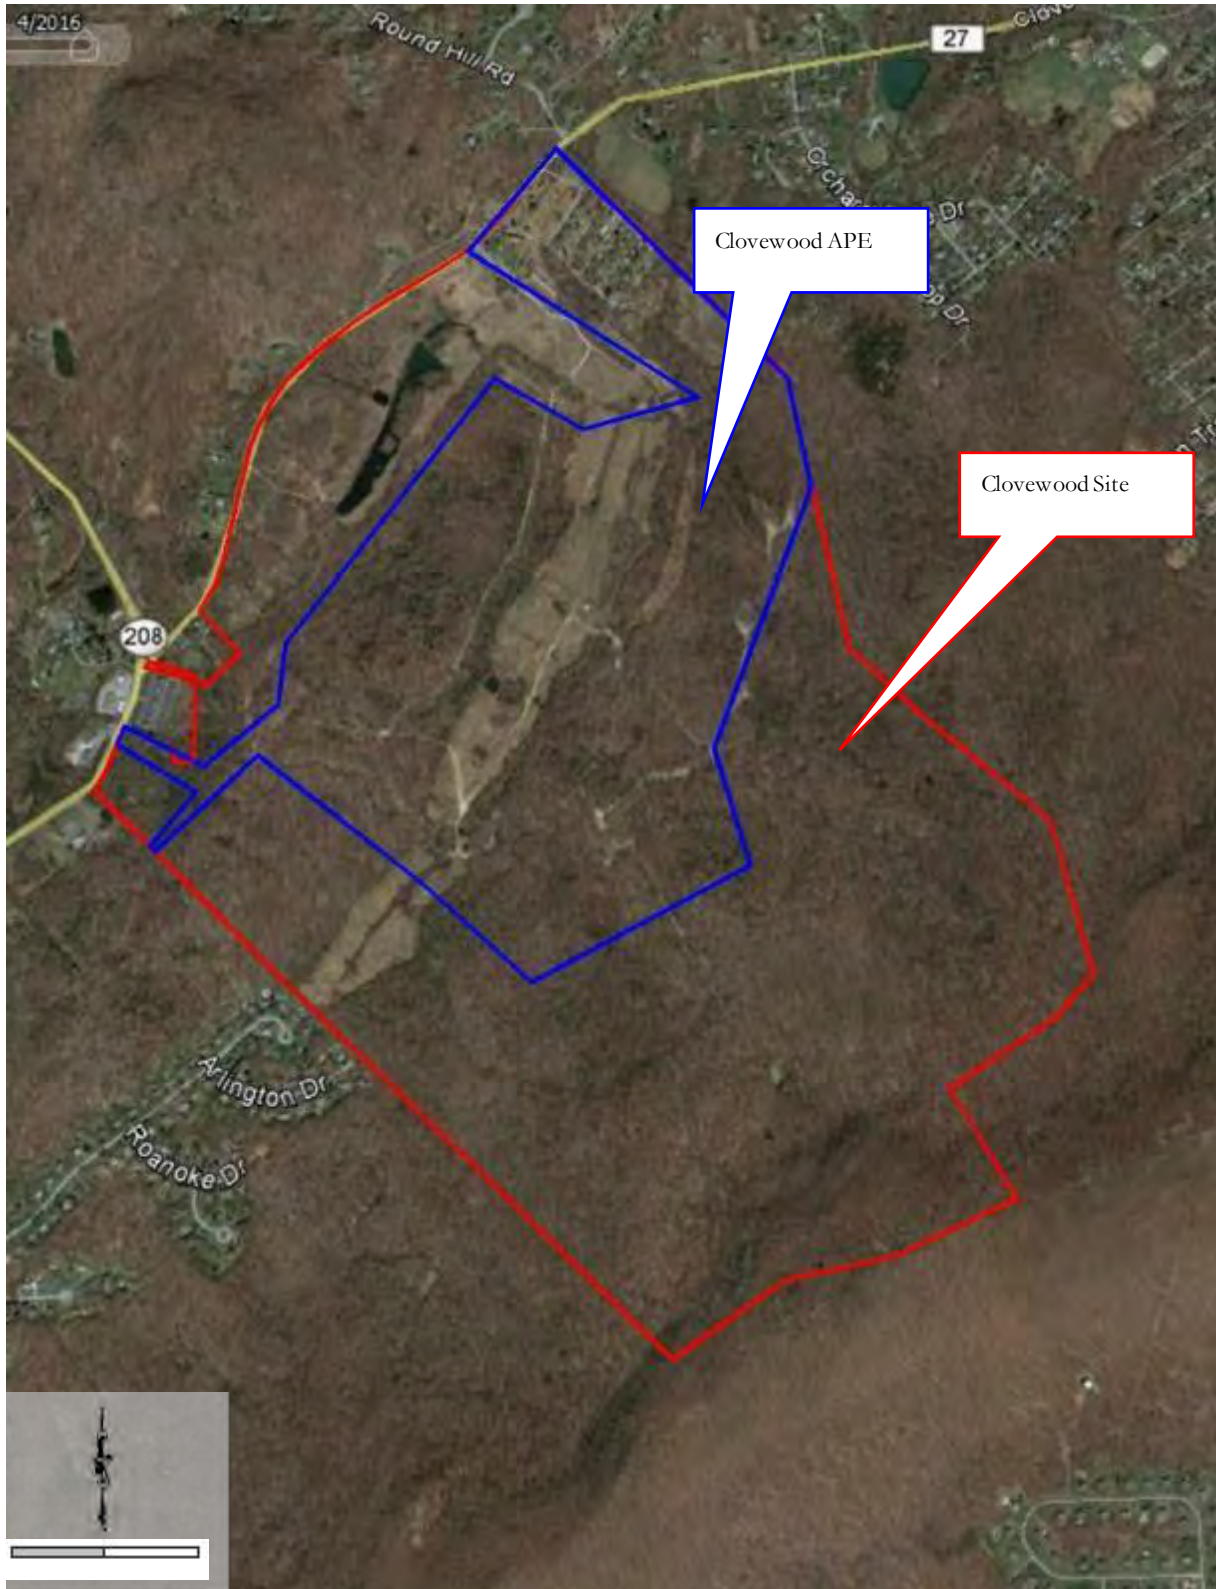
Figure 2: 2016 Aerial image of the project area. (Source: Google Earth.) Scale: 1"=1060.'

This aerial image, dated April 2016, shows the existing conditions of the Clovewood Site (red line) and the proposed APE (blue line). The former golf course is located in the central portion of the APE, and the existing network of roads can be seen throughout the APE.

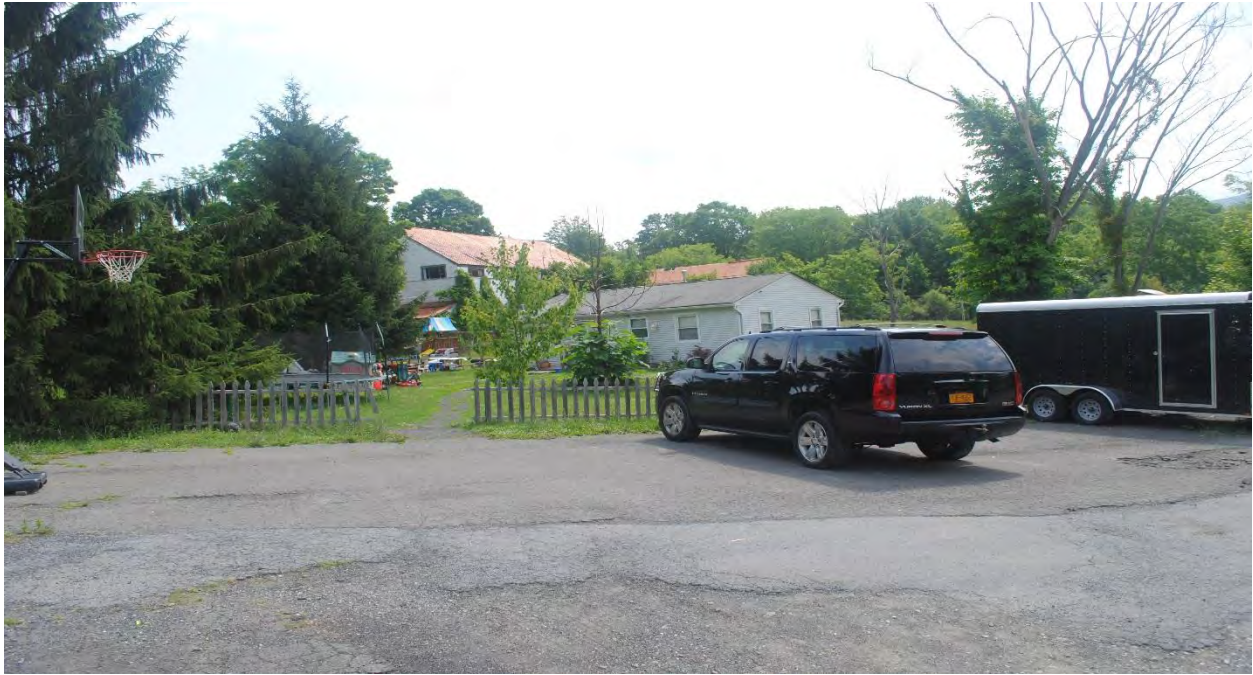
Photo 1: Existing structure located adjacent to the western entry way to the project area. View to the north.

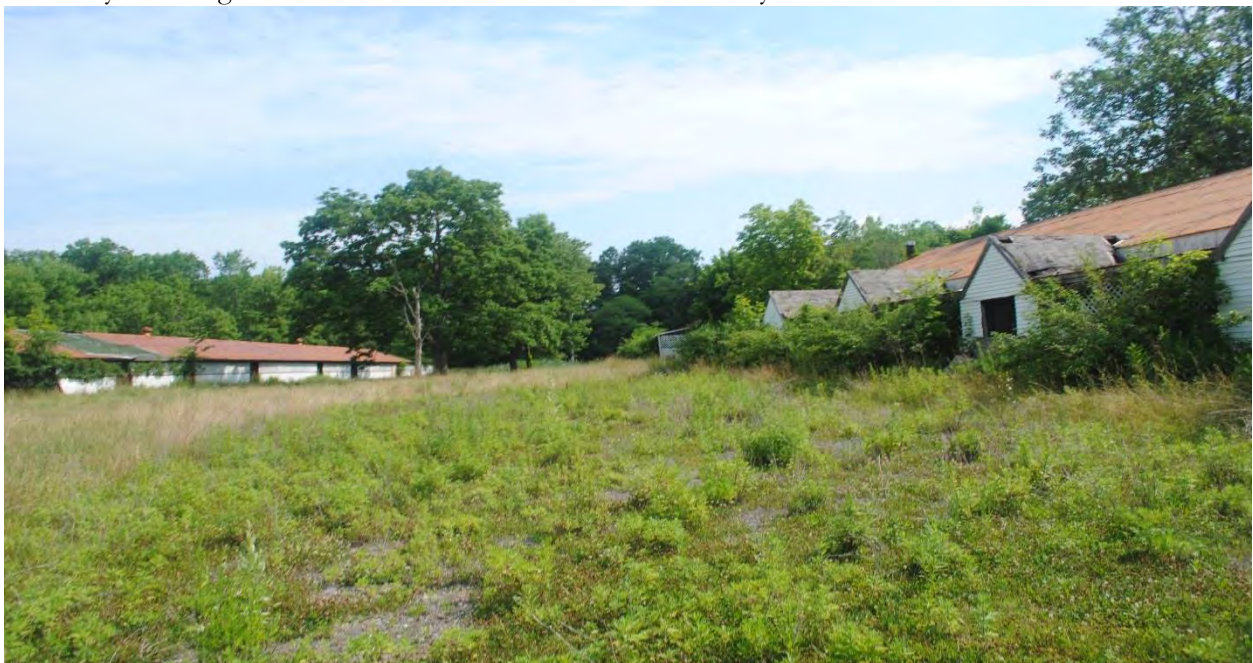
In the northern portion of the project area is a derelict housing complex (indicated on local signage as the Lake Anne Cottages). This residential neighborhood is in dilapidated condition, and consists of approximately 50 houses. The housing development appears to be on a flat hilltop that has been graded. There is relatively steep slope on all four sides of the knoll. South of this area are three large communal style buildings, apartments or similar style housing associated with the former Lake Anne County Club.

Photo 2: Apartment/hotel buildings located in the northwestern portion of the project area. These buildings are identified on the figure included in The Architectural Report. View to the north.

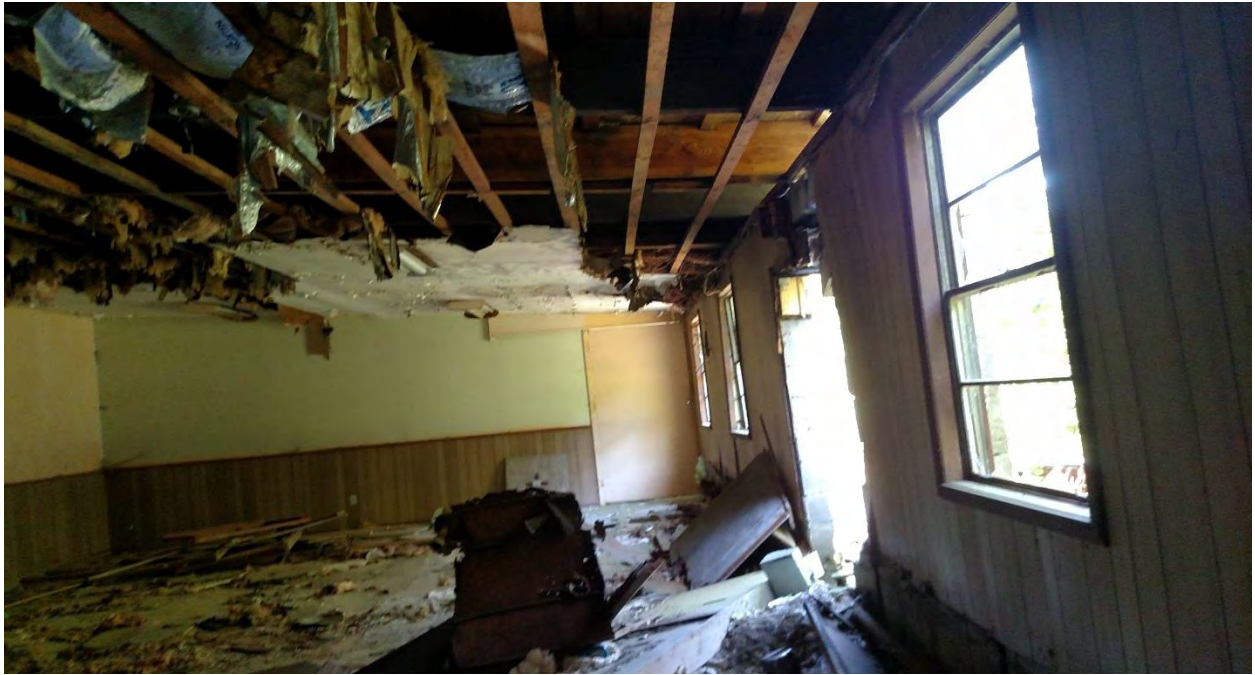
Area A contains what was once the Lake Anne Resort/Golf Club clubhouse, which is a Quonset hut style structure with divisions inside that represent a kitchen area, a dining and bar area and various storage and service rooms. This building dates to the Lake Anne Club era, approximately 1950-1960. It is currently in a decrepit condition. The inside is littered with a large quantity of both broken and intact 1960's to 70's mass produced restaurant ware and glassware. The roof of the structure is deteriorated and vegetation is beginning to grow within the walls of the structure.

Photo 4: Interior of the Clubhouse structure. The exterior walls of the building along with the interior of the structure is degraded.

- Photo 3: Residential structures are located in the northern portion of the project area. View to the east.
- Photo 4: Interior of the Clubhouse structure. The exterior walls of the building along with the interior of the structure is degraded.

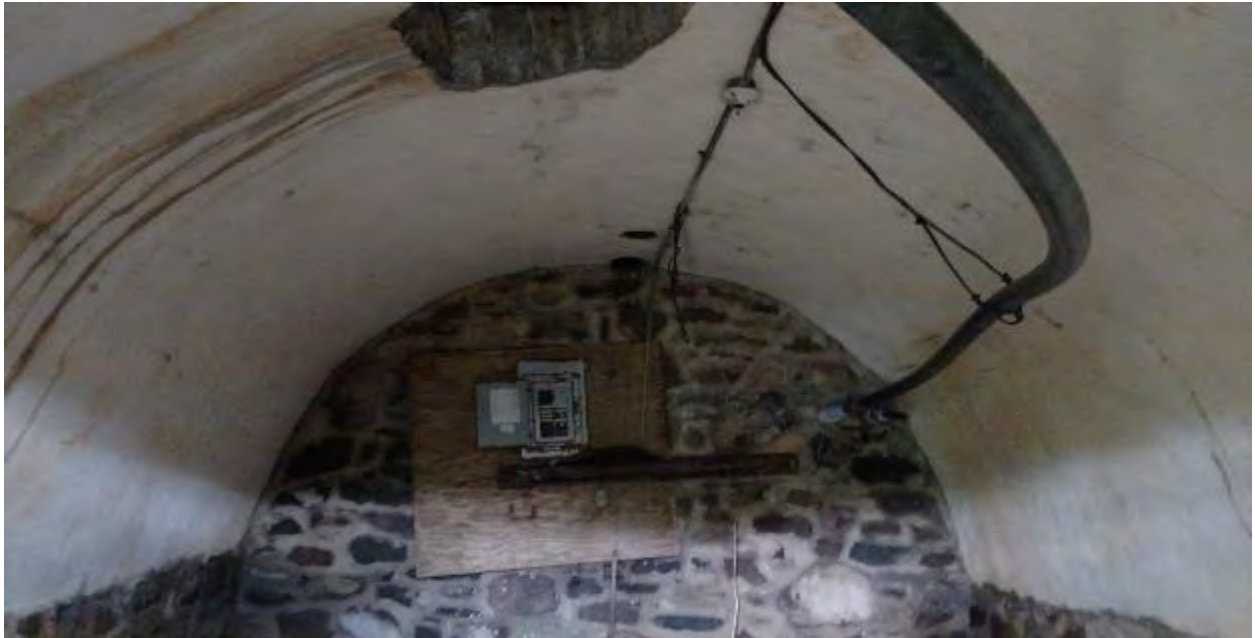
Photo 5: Interior of the spring house showing the modern electrical features.

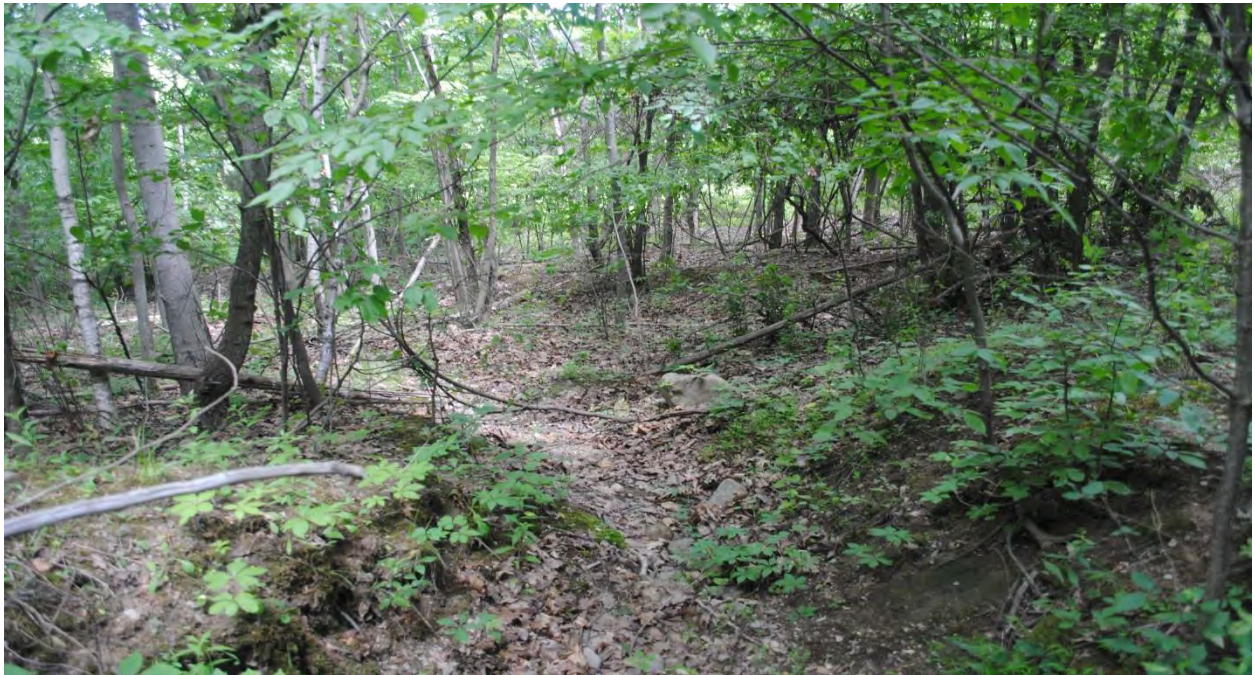
Photo 8: Area C is marked by significant alterations in the landscape. View to the north.

Along the northern boundary of Area C, the surface inspection identified an iron pipe and a substantial drainage system that appeared to be fed by a stream extending up the side of the mountain. The northwestern portion of Area C terminates in the eastern extreme of the Lake Anne golf course. Evidence of stratigraphic disturbance is evident in this locus despite the extremely dense vegetation cover of brush and opportunistic grasses. A total of 108 shovel tests were excavated along 11 transects in Area C, yielding a variety of soil profiles similar to those identified in Area B. Throughout the area evidence of subsurface disturbance was evident in the soils, with the majority of tests terminating in a silty loam with shale, channery and gravel. Overall, the testing in Area C documented a land surface that has undergone significant changes due to the installation of an extensive irrigation system in the ravine, as well the alterations to the ground surface for the golf course. No cultural materials were recovered from Area C.

- Photo 7: Area C is characterized by recent growth forest and gentle slopes on an undulating land surface. View to the west.
- Photo 8: Area C is marked by significant alterations in the landscape. View to the north.

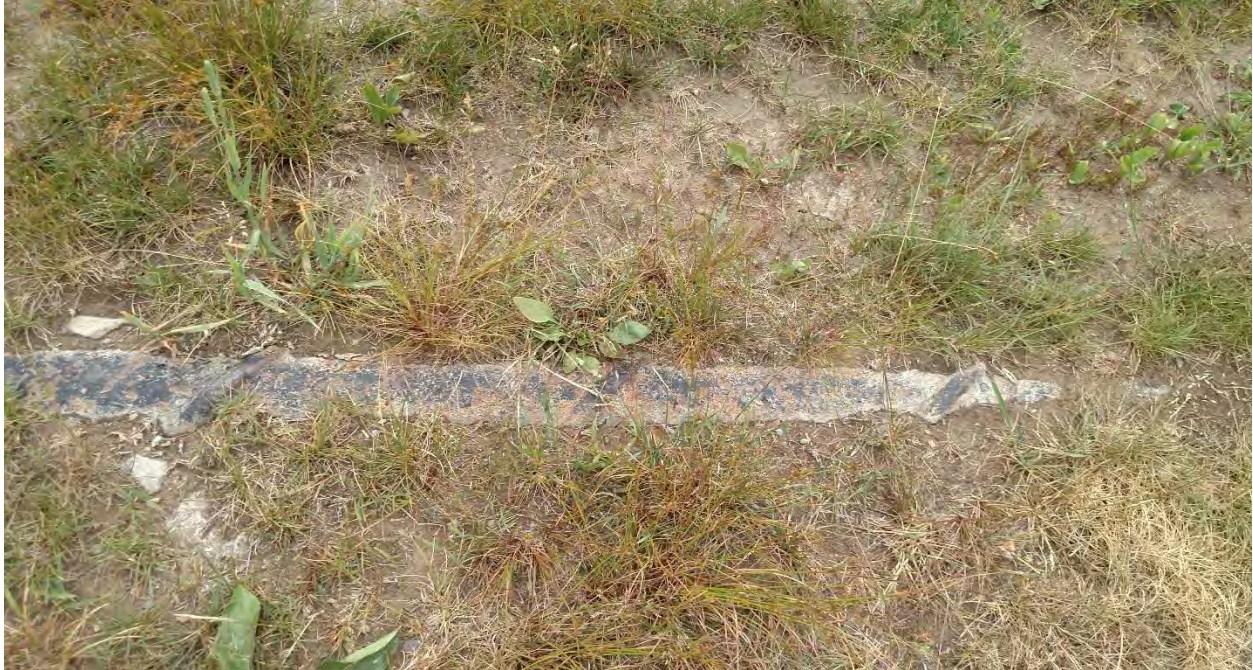
Photo 10: Area E contains subsurface iron infrastructure. View to the east.

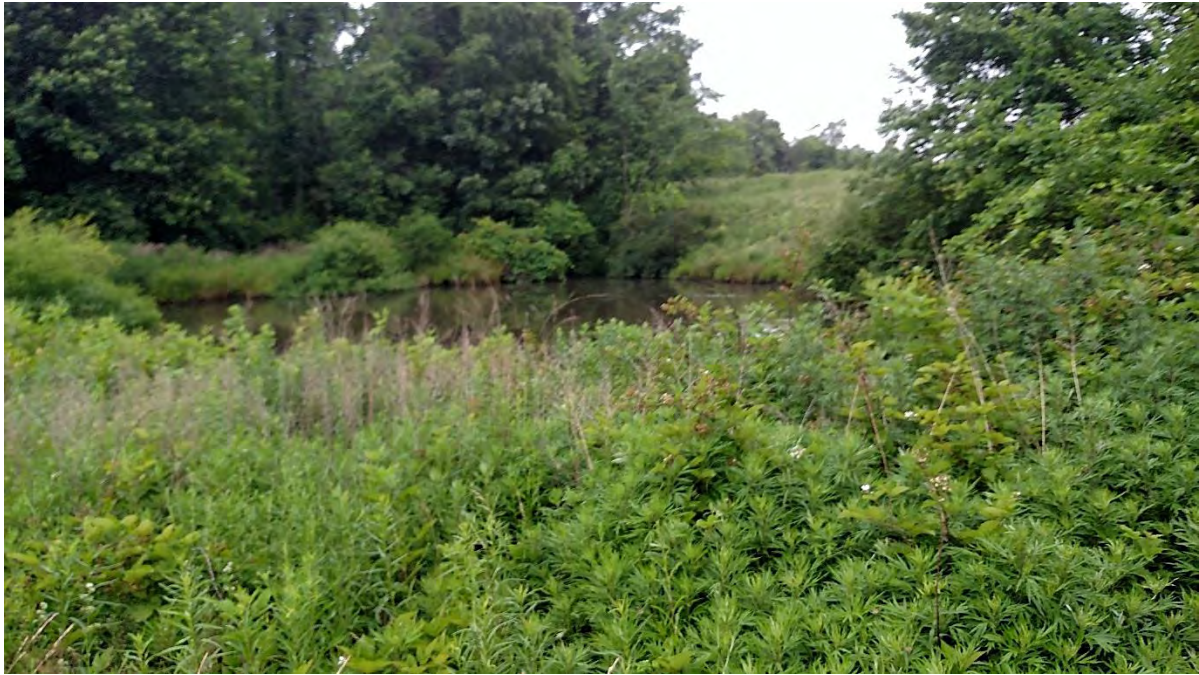
Area E is the location of a substantial and complex irrigation system that was installed to create adequate drainage and water supply for the golf course. Iron pipes and other metal irrigation features are evident across this knoll. Former greens and bunkers (sand traps) are still evident across the area. The landscape is marked by loci where significant surface alteration has taken place. Several large groups of trees occur on the crest of the knoll, most likely features of the golf course design. In addition, large earthen berms have been bulldozed into place at the southeastern boundary of the former golf course. This earth moving event took place more sometime after the golf course closed, as it cuts into portions of the former golf course.

Photo 11: A small pond is located in the western portion of Area E. This water feature was constructed as part of the golf course design.

- Photo 11: A small pond is located in the western portion of Area E. This water feature was constructed as part of the golf course design.
- Photo 12: A steep road cut bisects the southern tier of the golf course. View to the north. Principal investigator, Stephanie Roberg-Lopez completed a comprehensive walkover of the project area.

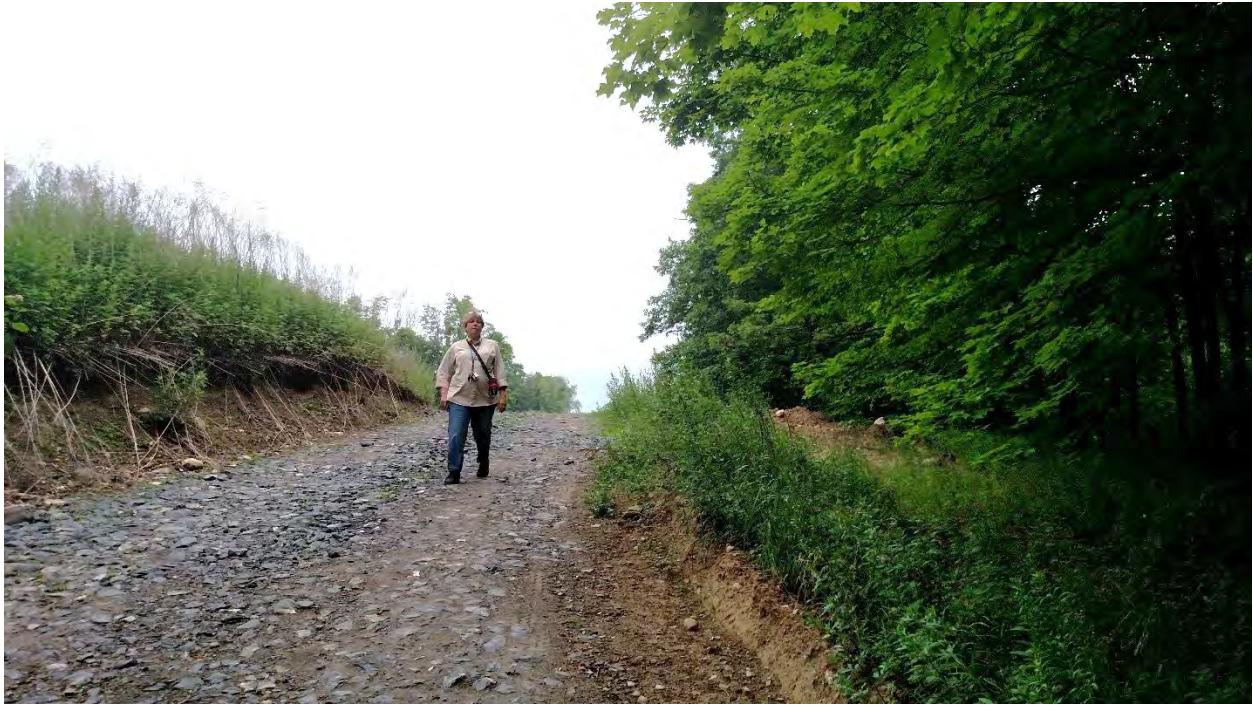
Photo 12: A steep road cut bisects the southern tier of the golf course. View to the north. Principal investigator, Stephanie Roberg-Lopez completed a comprehensive walkover of the project area.

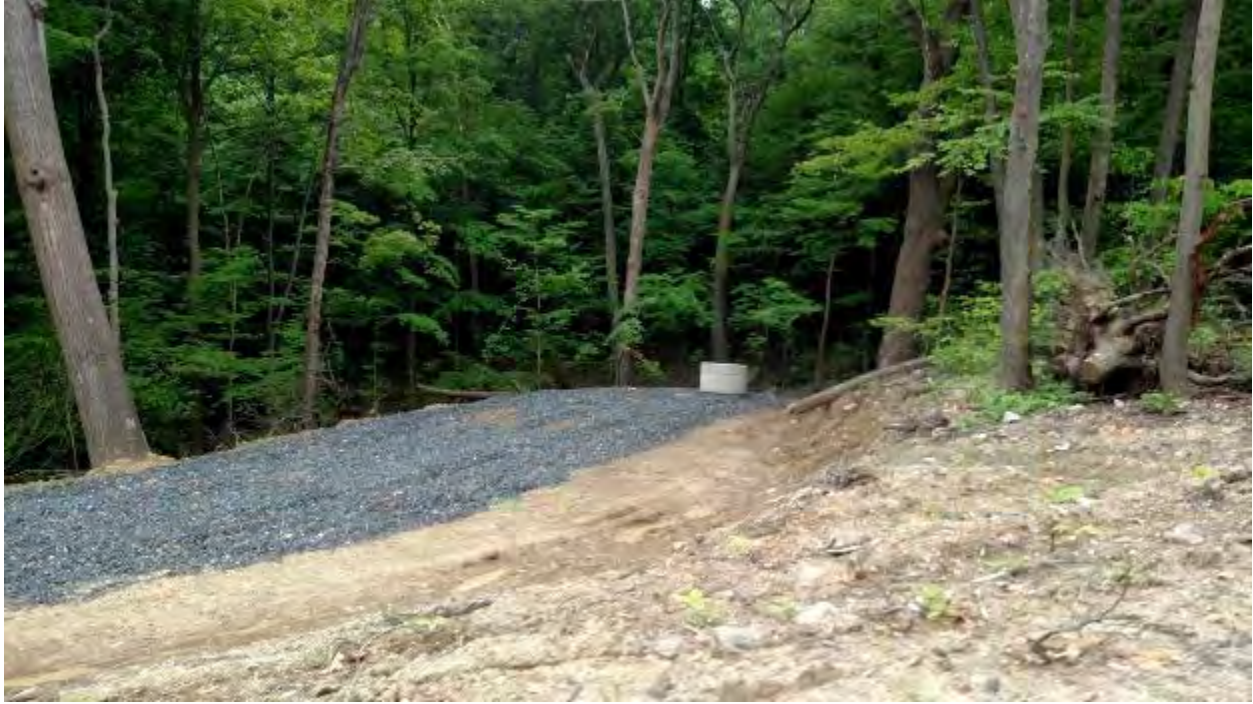
Photo 24: An access road and covered test well are located in the project area. View to the northeast.

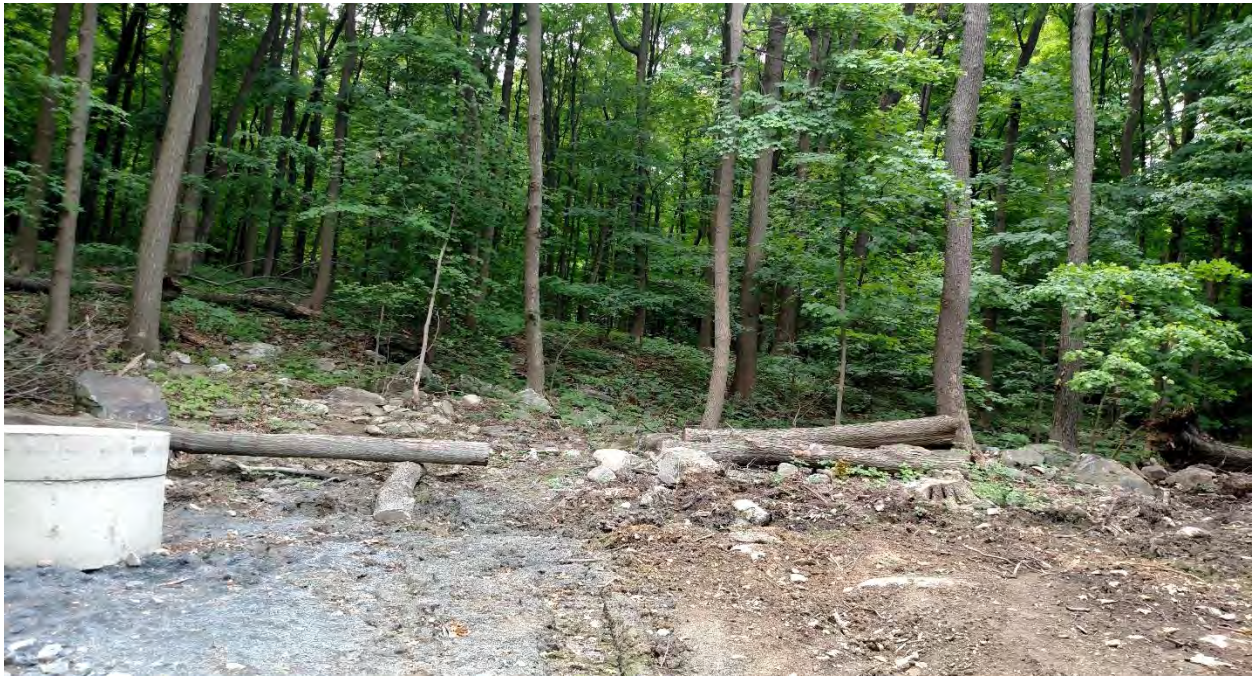
Photo 25: A covered test well is located within the project area. View to the west.

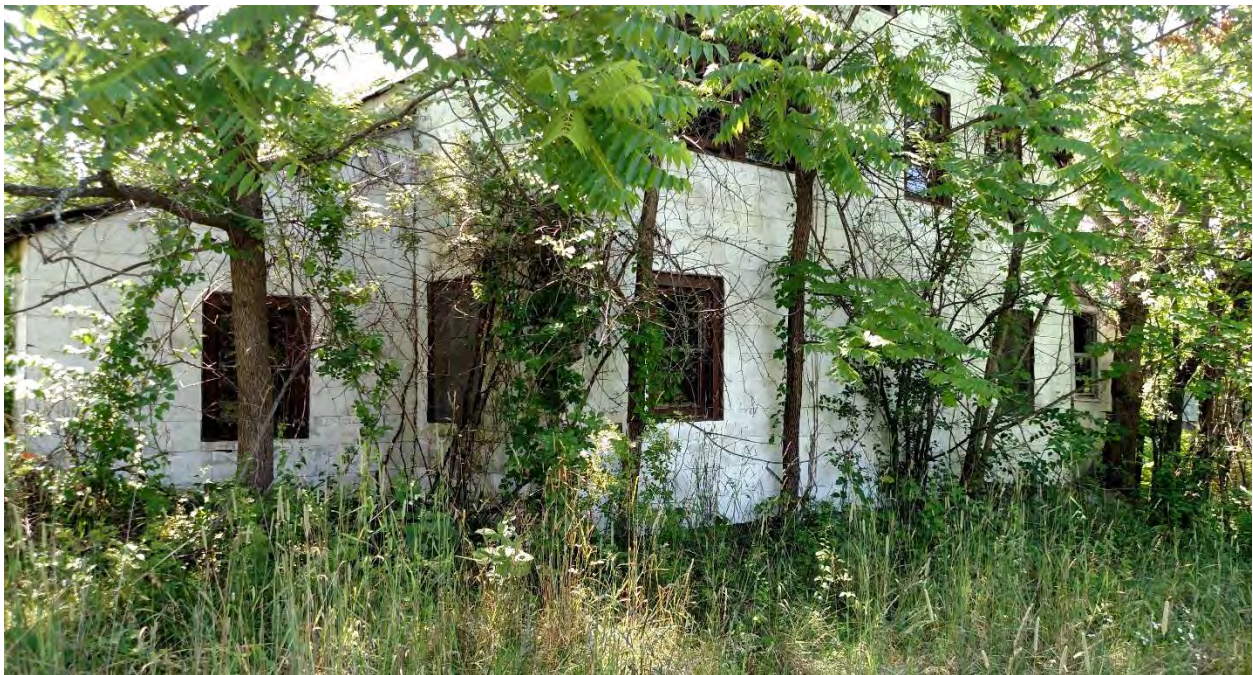
Photo 29: View south of the northern elevation of the H. Howell House.

The superstructure is three stories high with a peaked roof covered in aluminum sheeting. A single story addition is located on the northern side of the structure, and a small wooden porch is located on the northeastern side. A small wooden walkway connects the house to the Quonset Hut. This addition is constructed of cinderblock and has a corrugated steel roof. A small ell built on top of a field stone foundation is located on the western wall of the structure. The southern wall of the deteriorating fieldstone foundation

has been reinforced with corrugated sheet metal. The house is heavily overgrown with vines, briars and other thick vegetation.

The architectural integrity of the house has been compromised over the years by the small addition, the sheet metal used for wall separations and the installation of utilities to the house as evidenced by a network of pipes breaching the foundation. Electrical lines, currently disconnected from the poles but still connected to the exterior walls of the structure, indicate that the building was modernized, probably during the construction of the Lake Anne County Club. The ground area on the southeastern and eastern sides of the house which connect to the Quonset hut complex are profoundly disturbed. Piles of dirt and the uneven ground surface surrounding the structure indicate a significant amount of subsurface disturbance within the yard area of the house. The shovel tests excavated in the yard area documented highly disturbed stratigraphy. Modern items were identified within the shovel tests completed in this area. The landscape slopes to the east and northeast into a low lying area that contains standing water. This low lying area is located on the northern side of the Lake Anne Quonset Hut. Given the condition of the structure, it is not considered to be National Register Eligible.

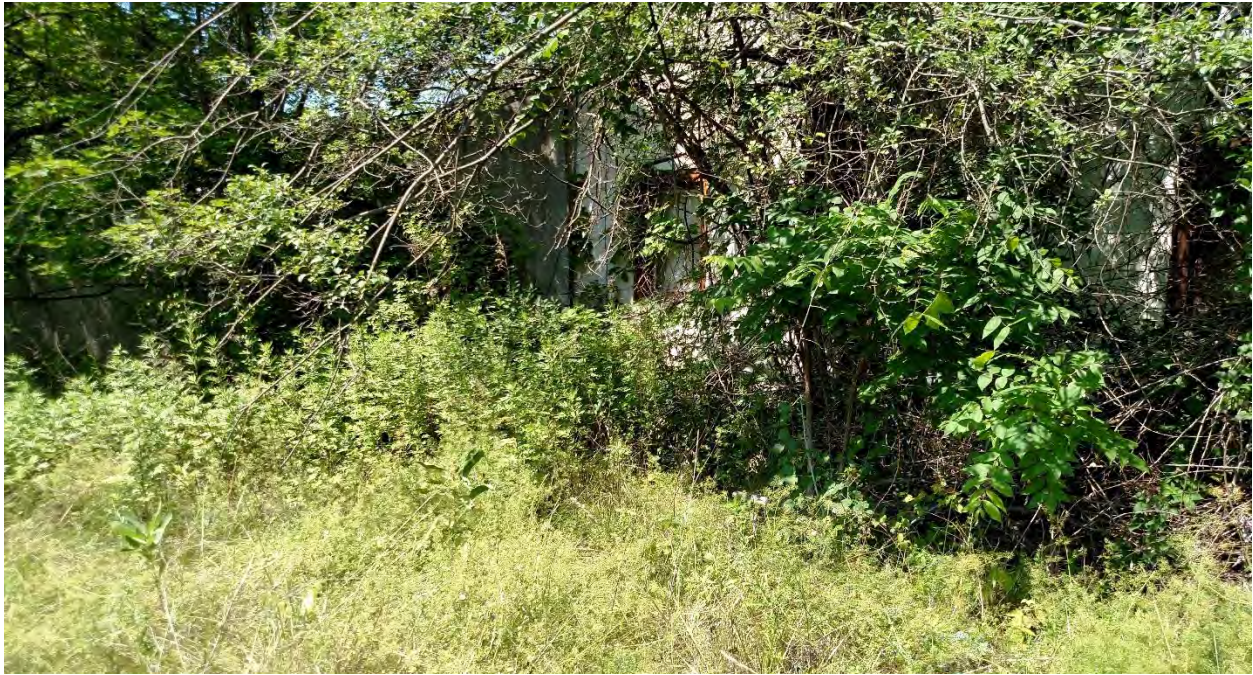
Photo 30: A wood frame addition connects the H. Howell house to the Quonset hut. View to the west. This elevation around the house is heavily overgrown with vegetation.

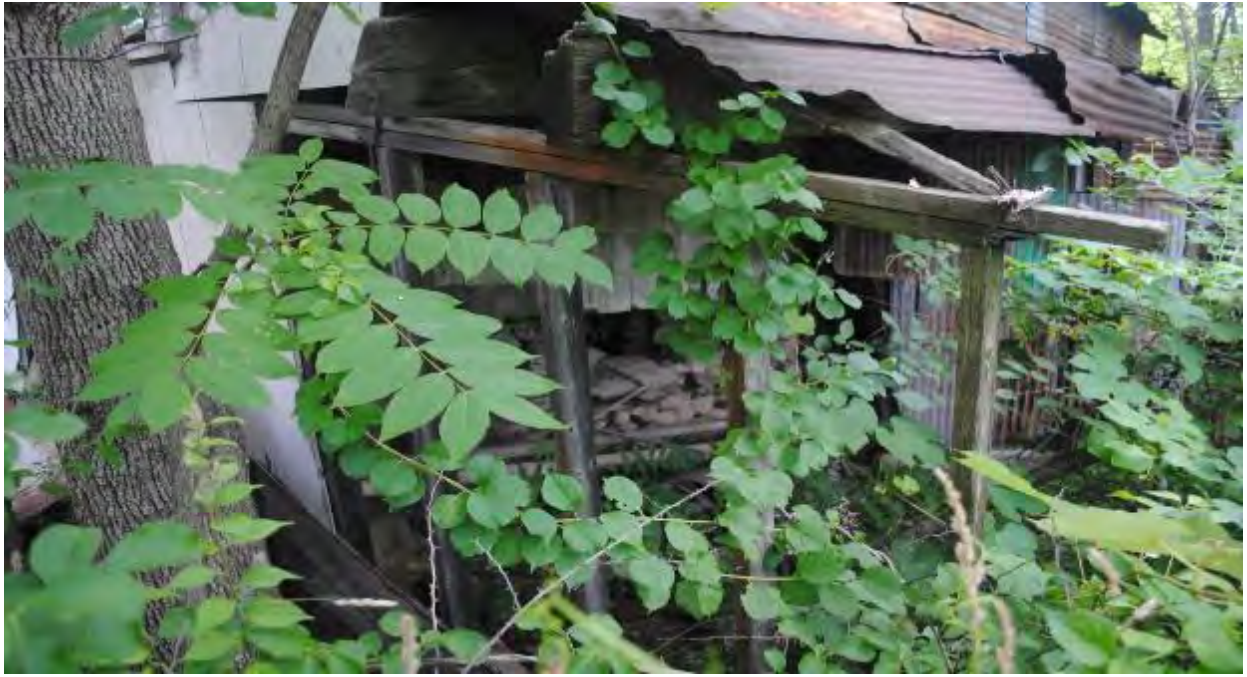
Photo 31: View of the dry laid field stone on the south western wall of the structure. The openings in the wall contain modern piping and have been reinforced with corrugated steel sheeting.

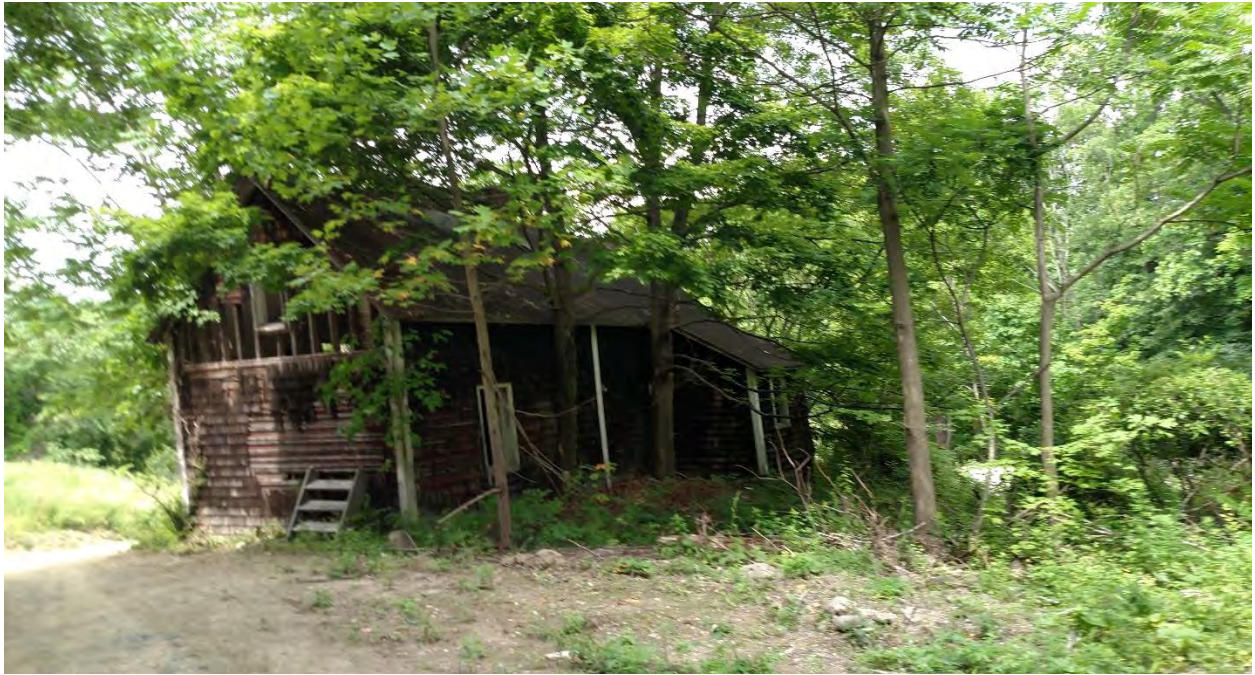
Photo 32: View to the west of the N.W. Howell House.

The N.W. Howell house is not considered to represent an intact historic cultural deposit. The yard area and foundation perimeter have experienced a series of disturbances, including the repairing of the foundation with modern cinderblock. The structure itself is in a state of disrepair. This building, which appears only on the 1903 map is not considered to be National Register Eligible in its current state of dilapidation.

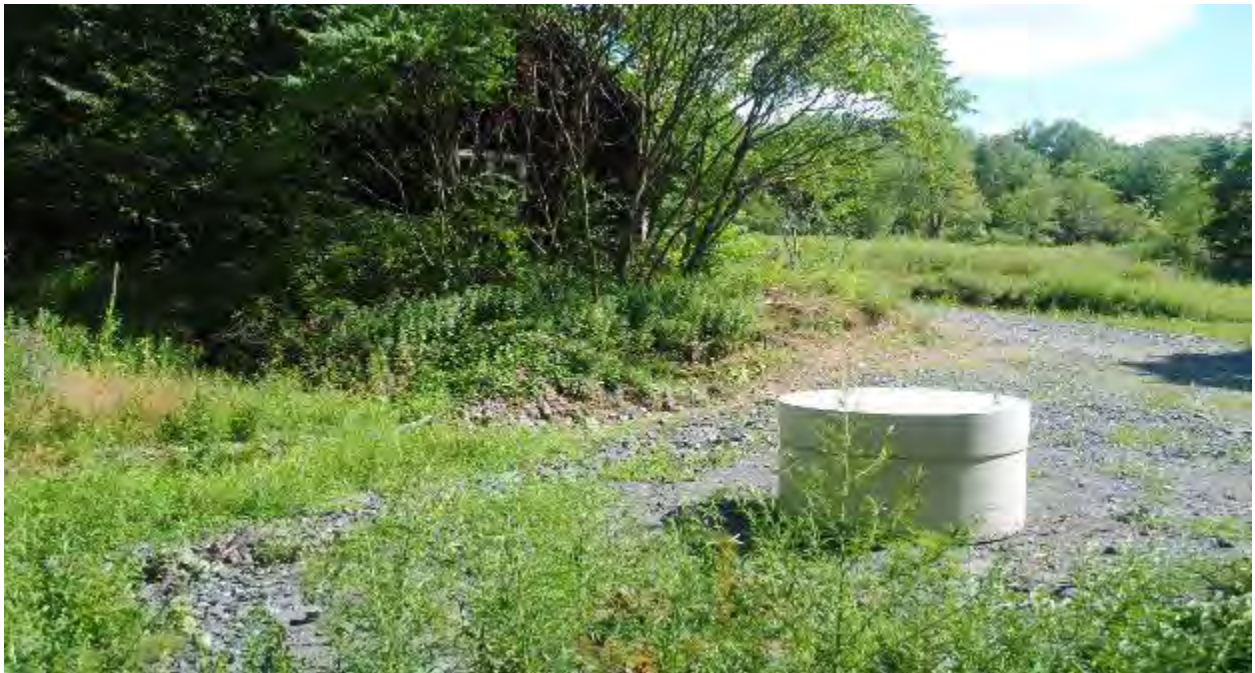
Photo 33: An existing well is located on the northwestern side of the N.W. Howell House. View to the northeast.

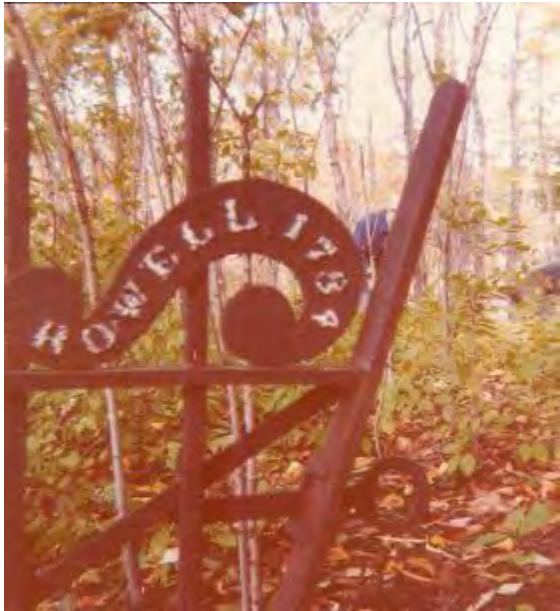
Photo 39: An undated image showing the gate that was formerly standing at the Howell Cemetery. Source: Findagrave.com.

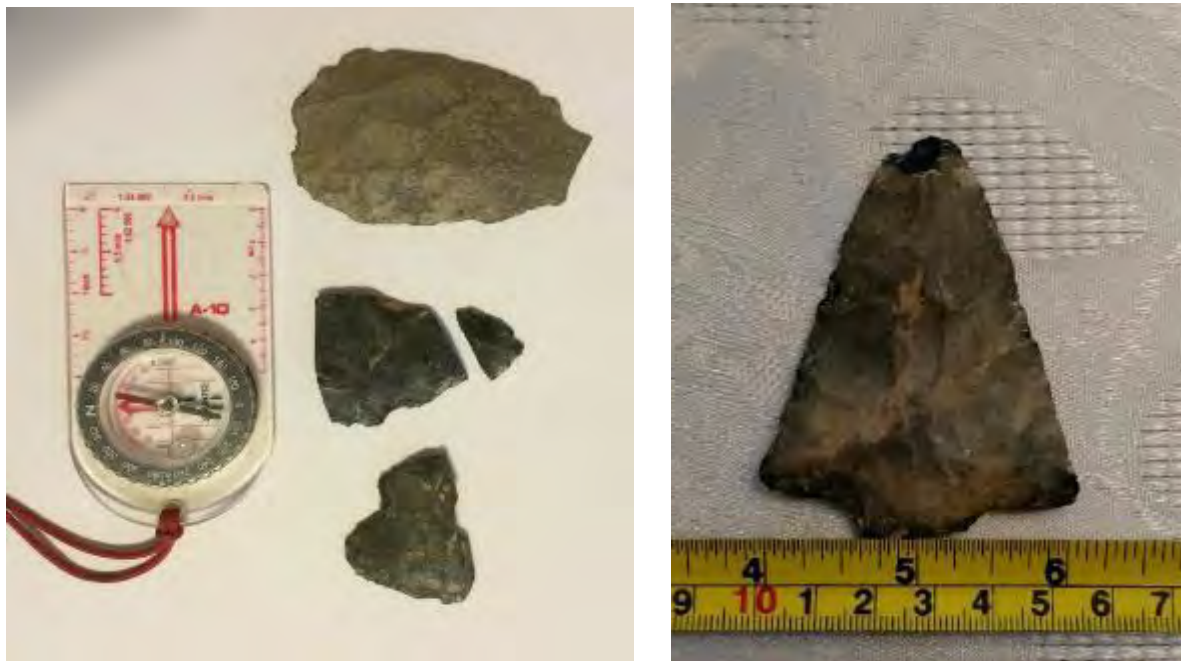
Figure 7: A sample of the artifacts recovered from the Schunemuck Prehistoric Site.

This locus, identified as the Schunemuck Prehistoric Site is located outside the boundaries of the Proposed APE and has been partially disturbed by the construction of roadways. In the event that the proposed development plan changes, additional investigation in this area is recommended. The artifacts were recovered from the surface where the construction of the existing roadway turned over the soils. The materials recovered consist of a large biface or celt, several utilized flakes and a projectile point. The base of the projectile point has been broken off, but the size and breadth suggest an Archaic affiliation.

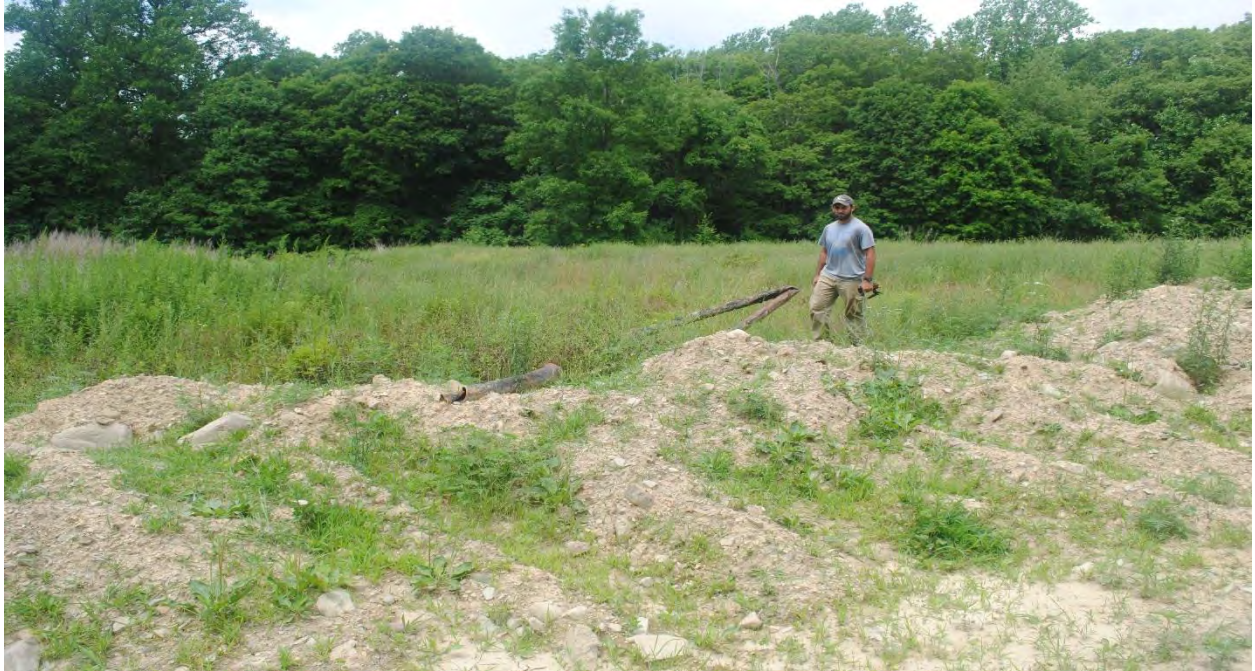
Photo 46: Within the former golf course earth moving activities had taken place to remove some of the former infrastructure. View to the north.

- Photo 45: Features of the former golf course are still evident within the landscape in Area E. View to the east of a bunker area.
- Photo 46: Within the former golf course earth moving activities had taken place to remove some of the former infrastructure. View to the north.

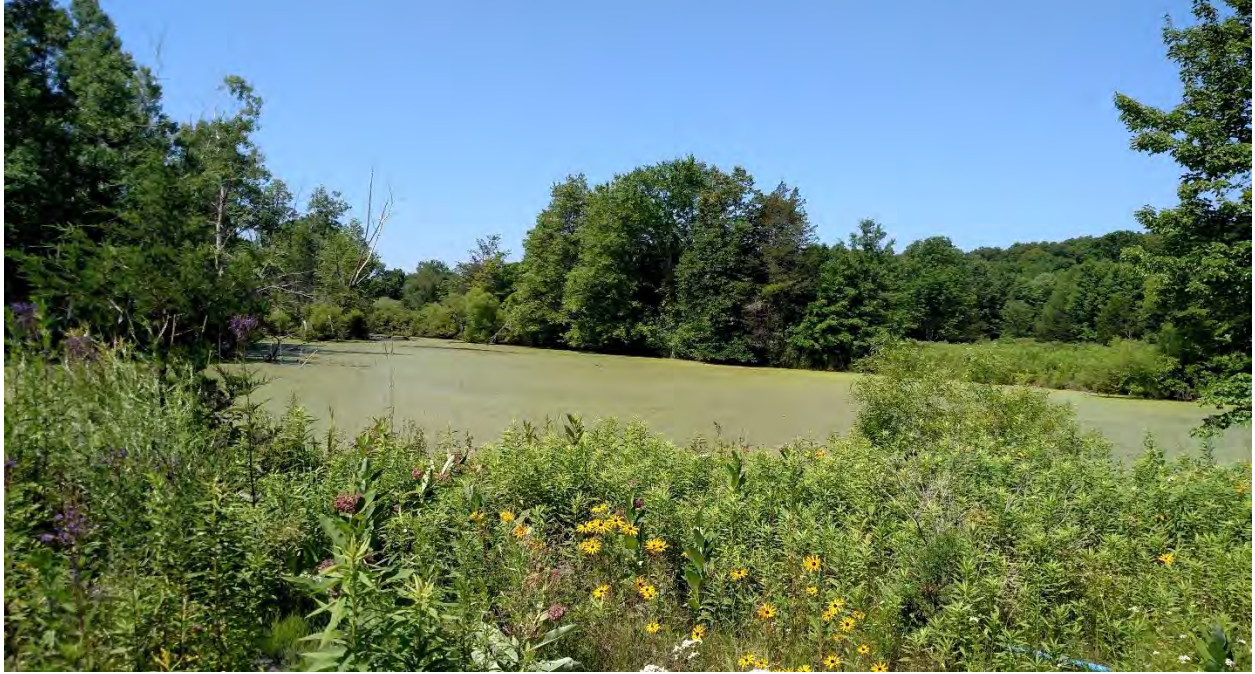
Photo 50: A wetland and pond is located in the western portion of the project area. This wetland features a small dam at its southwestern tip. The 1958 aerial shows this dam is in place.

- Photo 49: The streams and other small drainages are located within steep ravines. View east of the steep ravine located within Area F.
- Photo 50: A wetland and pond is located in the western portion of the project area. This wetland features a small dam at its southwestern tip. The 1958 aerial shows this dam is in place.

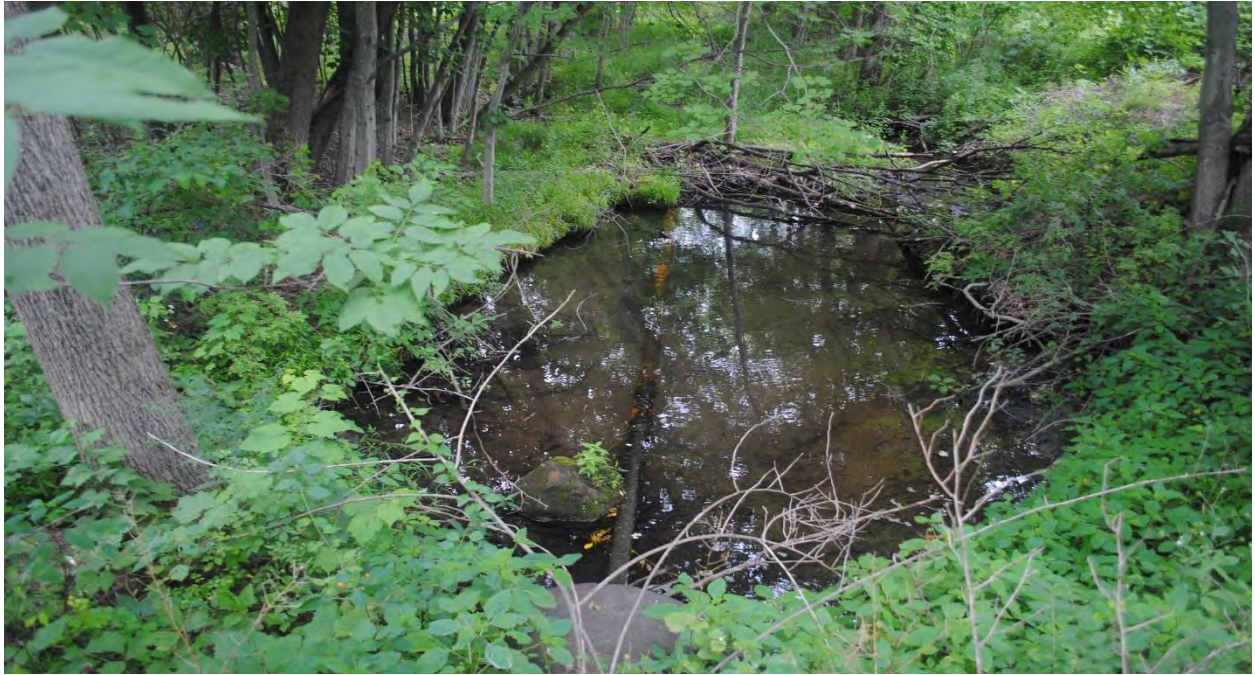
Photo 51: Areas of standing water are located in drainage ditch. View of standing water in Area F.

- Photo 51: Area of standing water are located in drainage ditch. View of standing water in Area F.
- Photo 52: Pieces of drainage culverts were found within the project area. They are likely associated with a late 19th century irrigation system on the property.

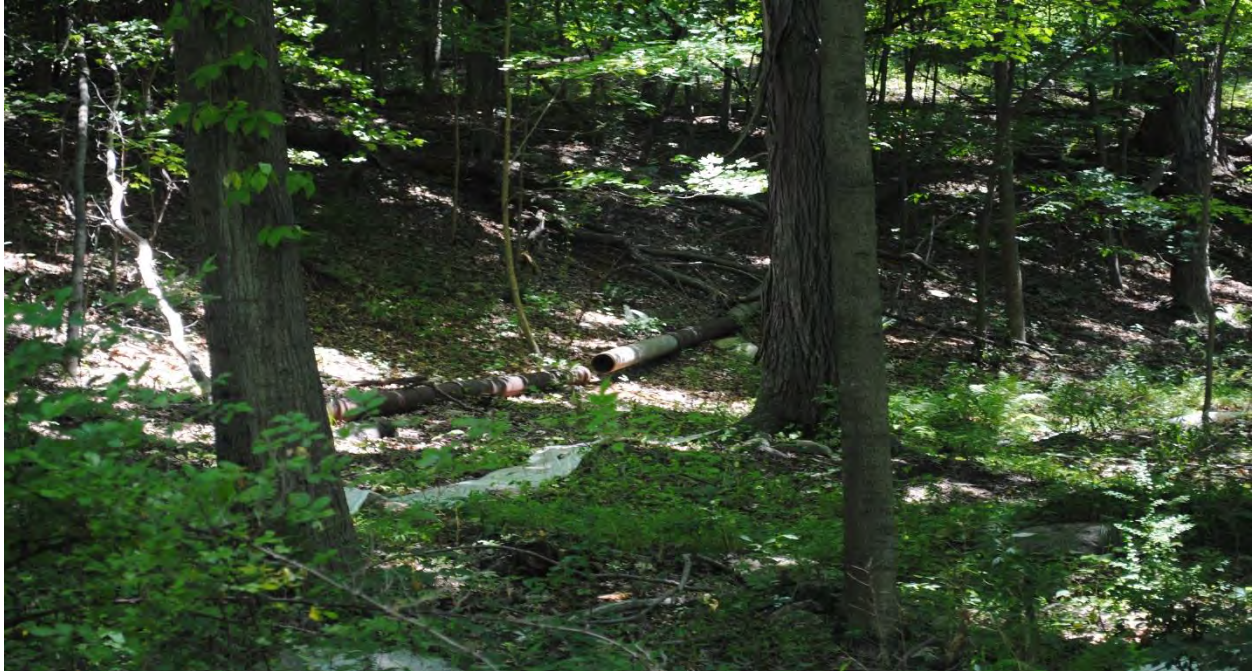
Photo 52: Pieces of drainage infrastructure were noted within the project area. They are likely associated with a late 19th century irrigation system on the property.
