APPLICATION PACKAGE
NYSDEC WATER WITHDRAWAL PERMIT

CLOVEWOOD WATER SYSTEM
BLAGGS CLOVE
VILLAGE OF SOUTH BLOOMING GROVE
ORANGE COUNTY, NEW YORK

PROJECT NO.: 31404120.000
DATE: APRIL 2018
(REVISED: JULY 2023)
(REVISED: SEPTEMBER 2023)
(REVISED: OCTOBER 2023)

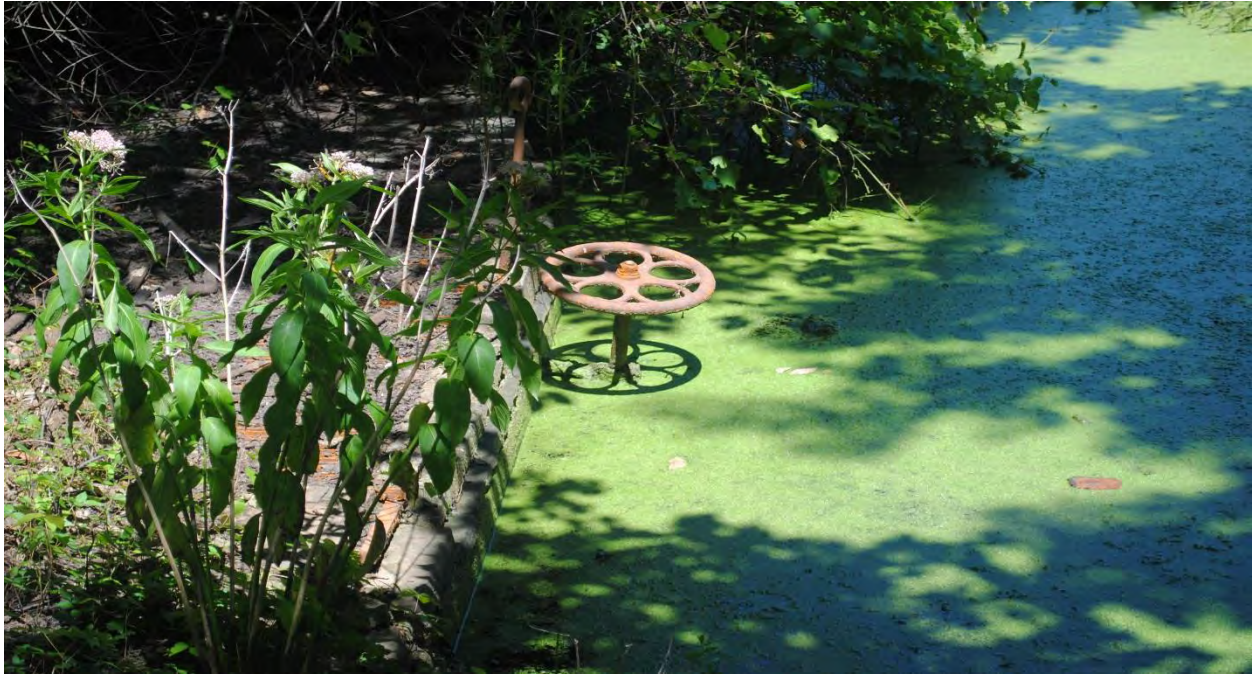
Photo 53: View of the dam located at the southern tip of the wetland. This dam is located 500' north of the M.H. Howell complex and is outside of the APE. Based on the cement and metal hardware, this feature was probably constructed during the late 19th century to early 20th century.

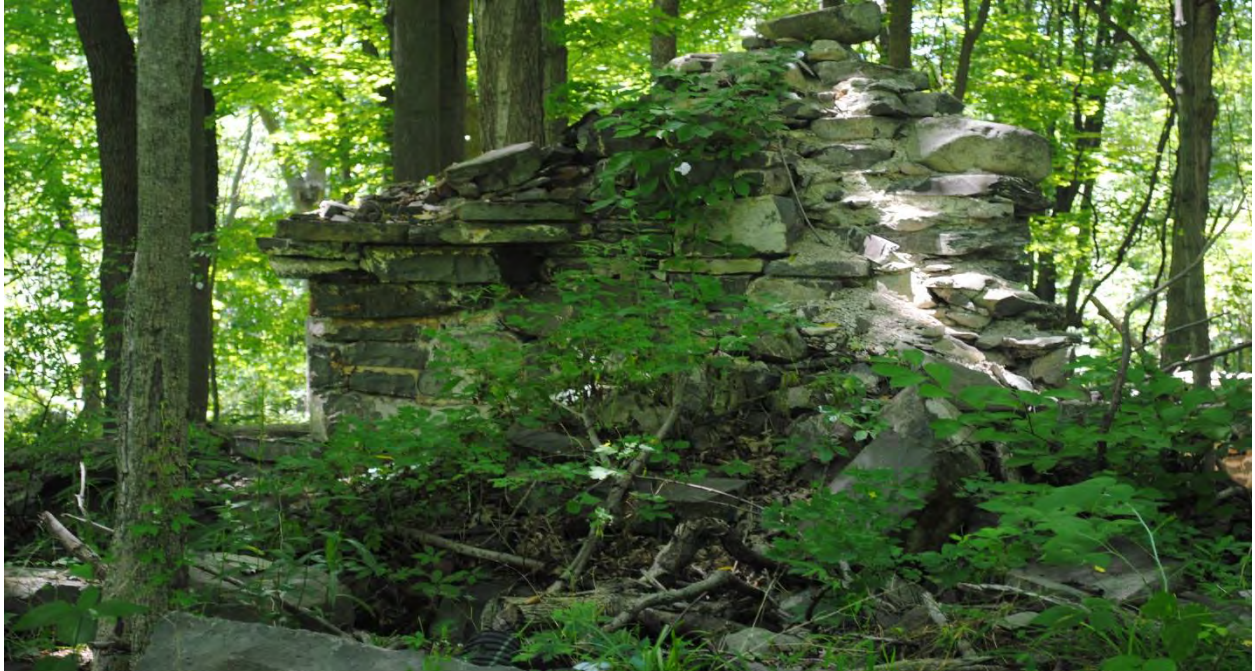
Photo 54: Remnants of a fireplace located on the southern wall of the M. H. Howell foundation structure. View to the east.

- Photo 54: Remnants of a fireplace located on the southern wall of the M. H. Howell foundation structure. View to the east.
- Photo 55: The various walls of the M. H. Howell foundation show several different construction styles. View to the north.

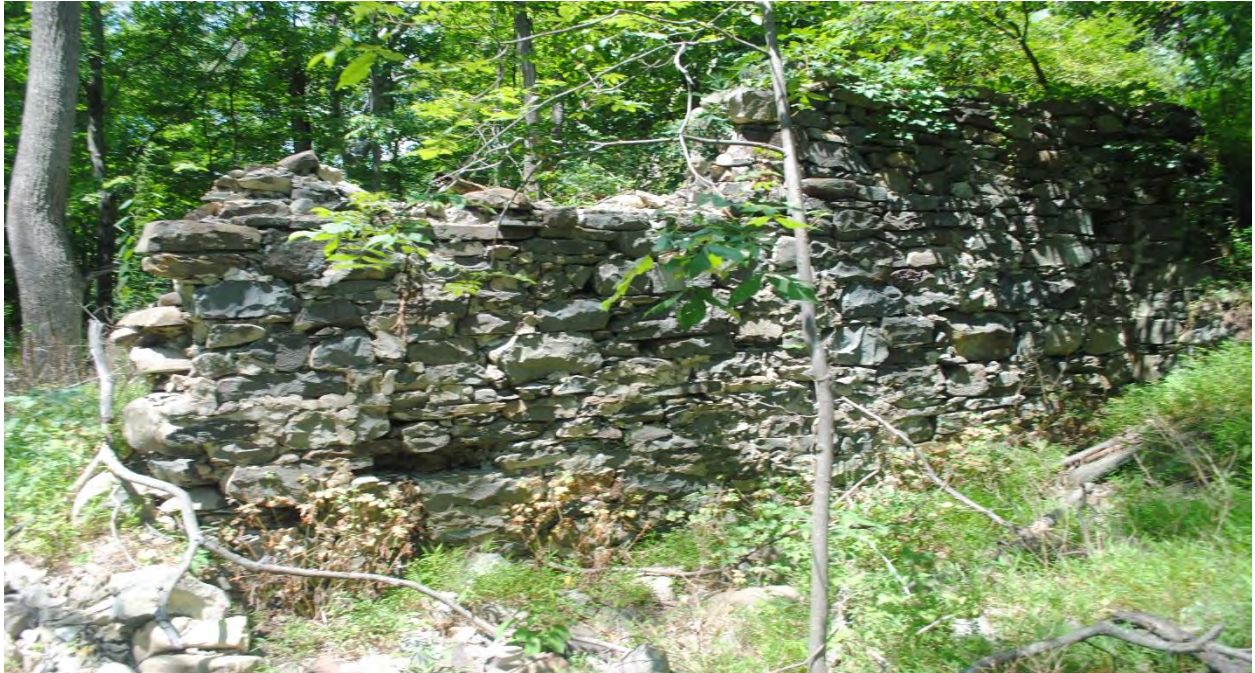
Photo 55: The various walls of the Howell foundation show several different construction styles. View to the north.

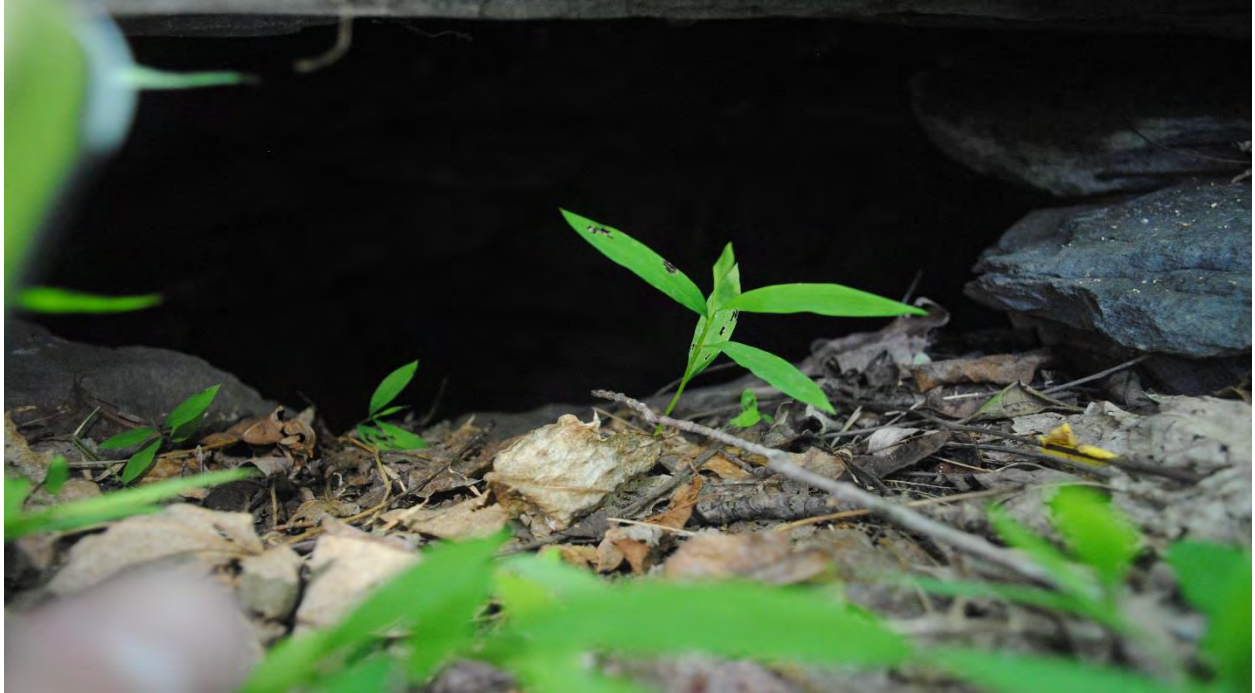
Photo 56: A small well was identified adjacent to the southeastern corner of the main structure. Well is approximate 4' in diameter.

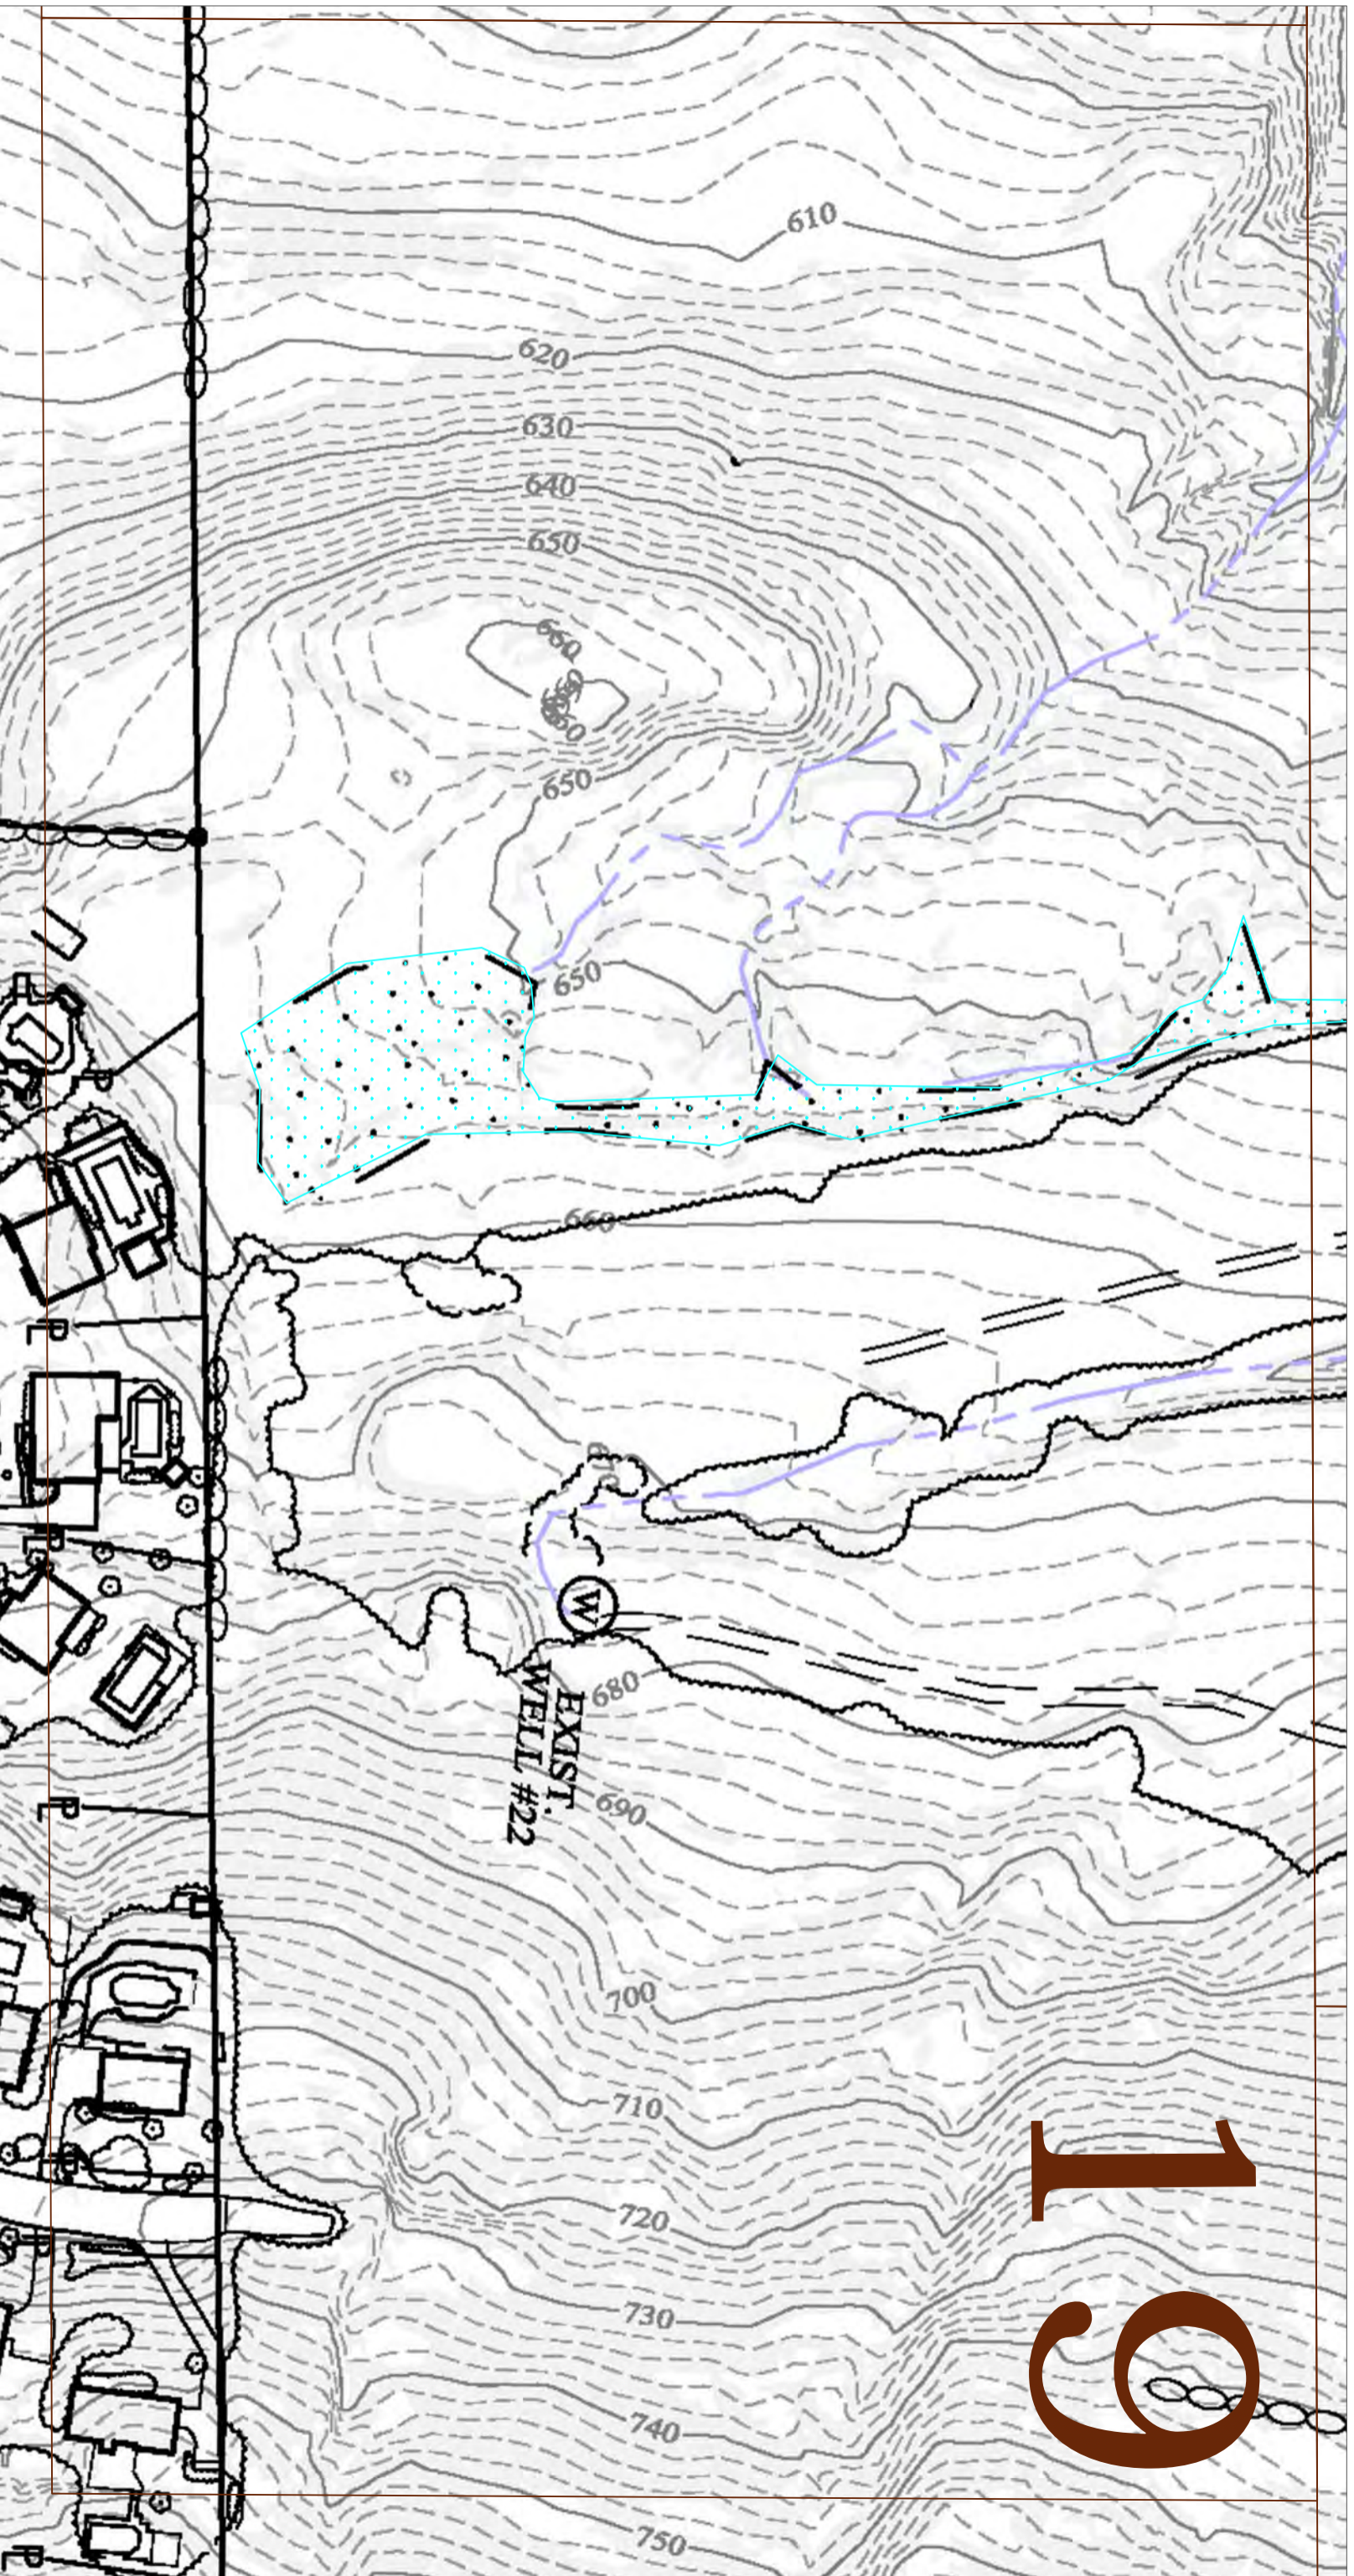
- ST Sterile Shovel Test Location
- ➡ Photographic View
- Phase 1B Testing Sub Areas
- Areas of Standing Water or Wetland
- Wetland Buffer
- Areas of Slope >12%
- Clovewood APE
